Smoke and Dye Testing Summary

High Level Sewershed

Test ID	Test Type	Date Inspected	Company / Super.	Blower MH	Ground Condition	Notification Made?	Total Length
S1028-044	Smoke	9/5/2008	ADS/TM	S13GG1008MH	Dry	Yes	528.13

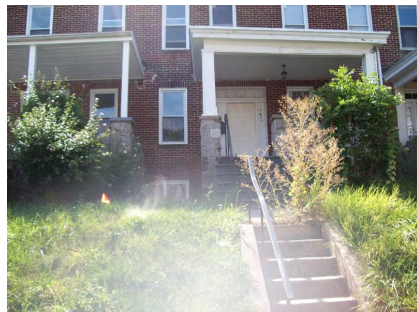
Picture \S1028-044-OB01-P01.jpg

Comments Smoke from cleanout in front yard. 2615 Park Heights Terr

Comments Front of house, 2615 Park Heights Terr
